DESCRIPTIVE REPORT

Type of Survey Field Examination

Registery No. FE-298

General Locality Sitka

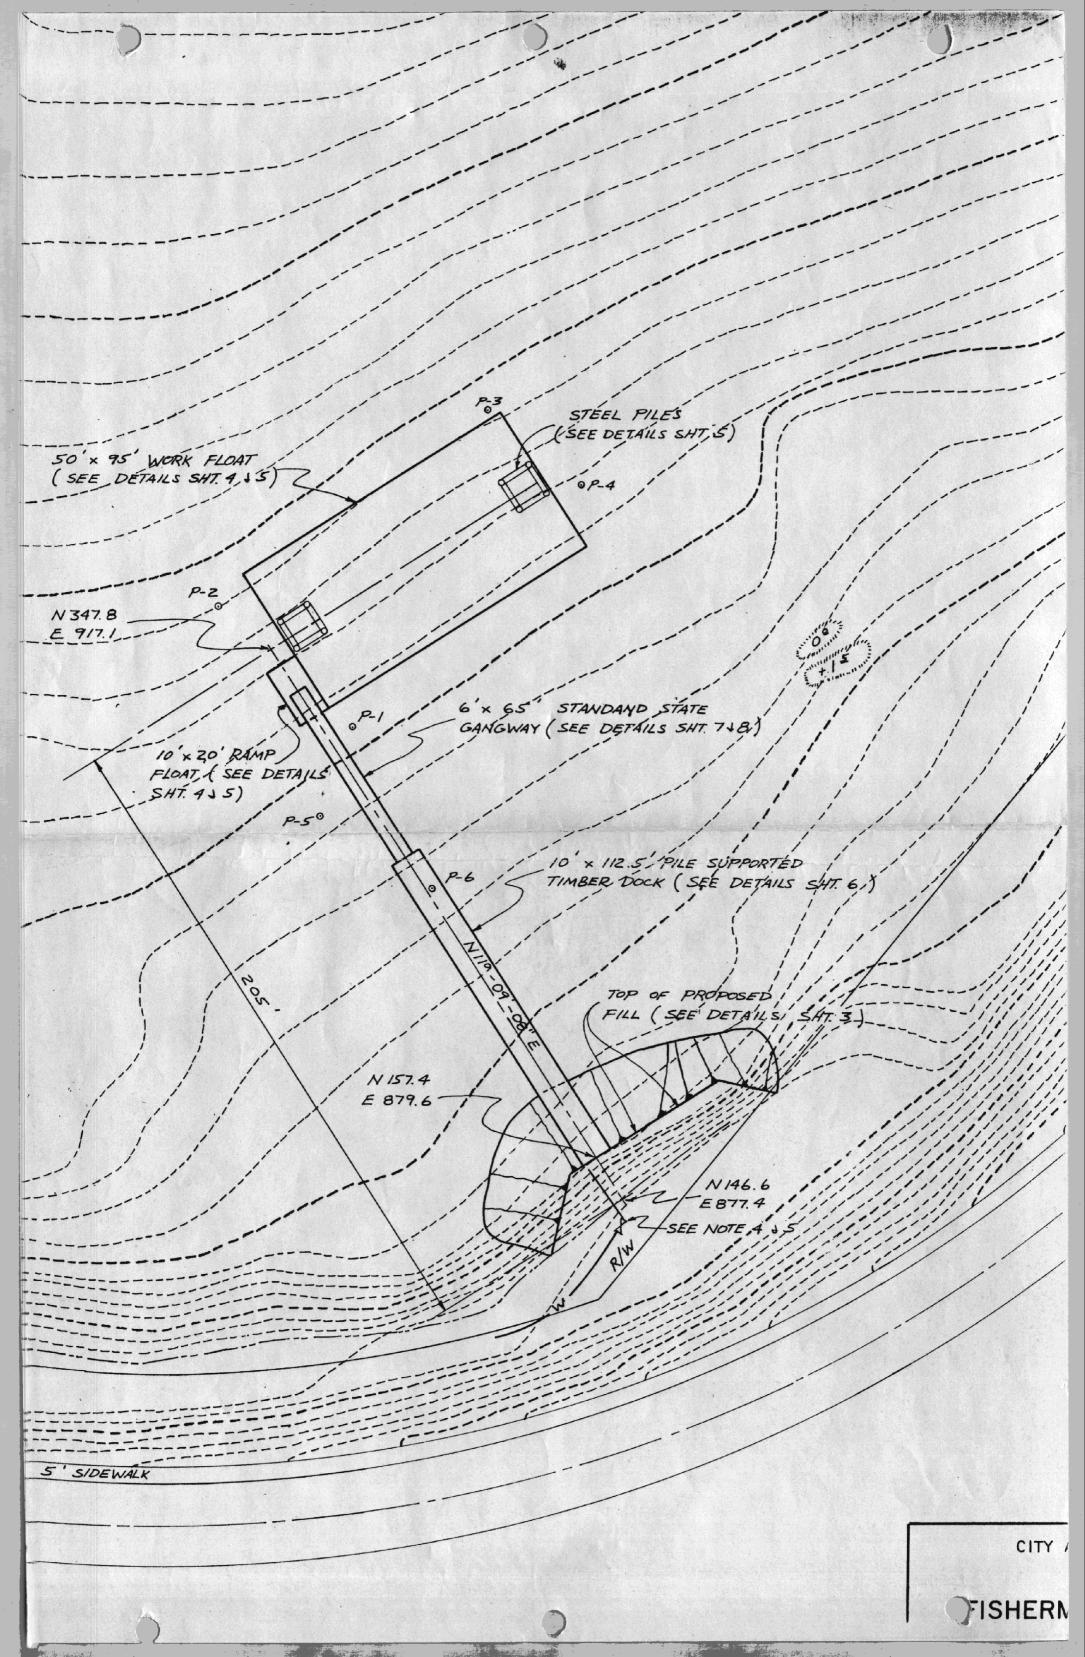
Plans for new pier in Sitka Harbor.
ON ORIGINAL DOCUMENT (See Section P of report.)
